Steam line repair work under way at Hawthorn Station

The following information appeared in the Kansas City Power & Light publication 'Light Lines' dated September 8, 1998.

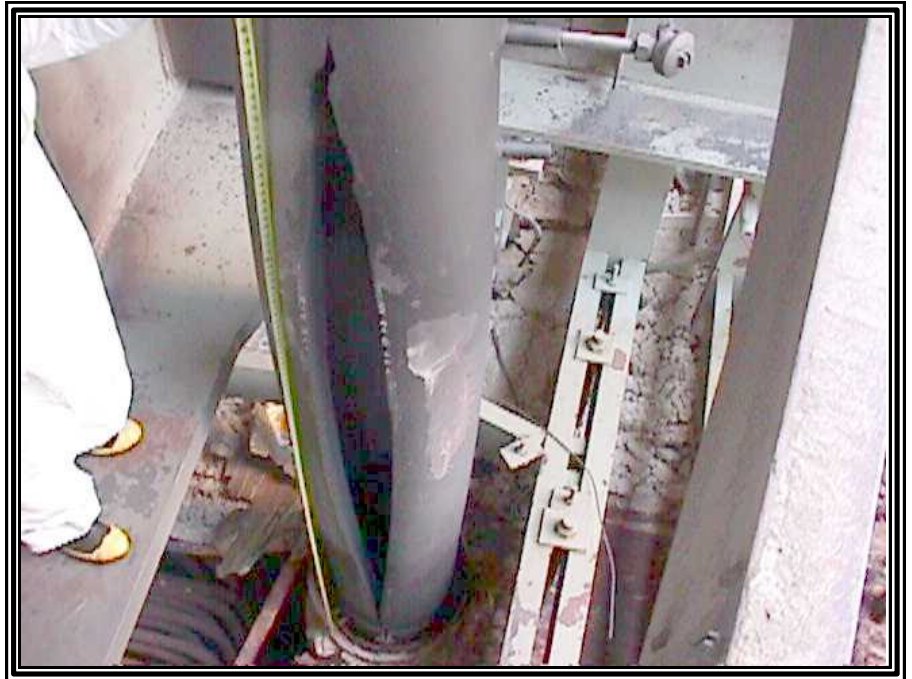
"When the line blew open, the 2,400 pounds of high-pressure steam caused other auxiliary piping in the area to be moved as much as 5'," he explains. "Small 'I' beams were bent; grating, roofing and siding were blown off the boiler; and pipe

Hawthorn's pipe is 18" in circumference and 2-1/2" thick. The rupture caused a tear 9' 11" long, with the widest gap being 7-1/2".

hangers were bent. And one of the critical parts needed to bring this unit back on line – the secondary superheater header, which is at the highest temperature and pressure section of the boiler – was forced off its supports and is about a foot from where it was."

All the manufacturer's records for the pipe at Hawthorn indicate it was supposed to be seamless, but obviously it wasn't. "There have been other documented incidents of ruptures and other failed seams on steam lines, but it is not a common occurrence," Spring adds.
