SUMMARY OF FIELD EXPERIENCE FOR ACOUSTIC EMISSION MONITORING OF SEAM-WELDED HIGH ENERGY PIPING

J. M. Rodgers
Acoustic Emission Consulting
5000 San Juan Ave, Suite D
Fair Oaks, CA 95628

R. M. Tilley
EPRI
1300 W.T. Harris Blvd
Charlotte, NC 28262

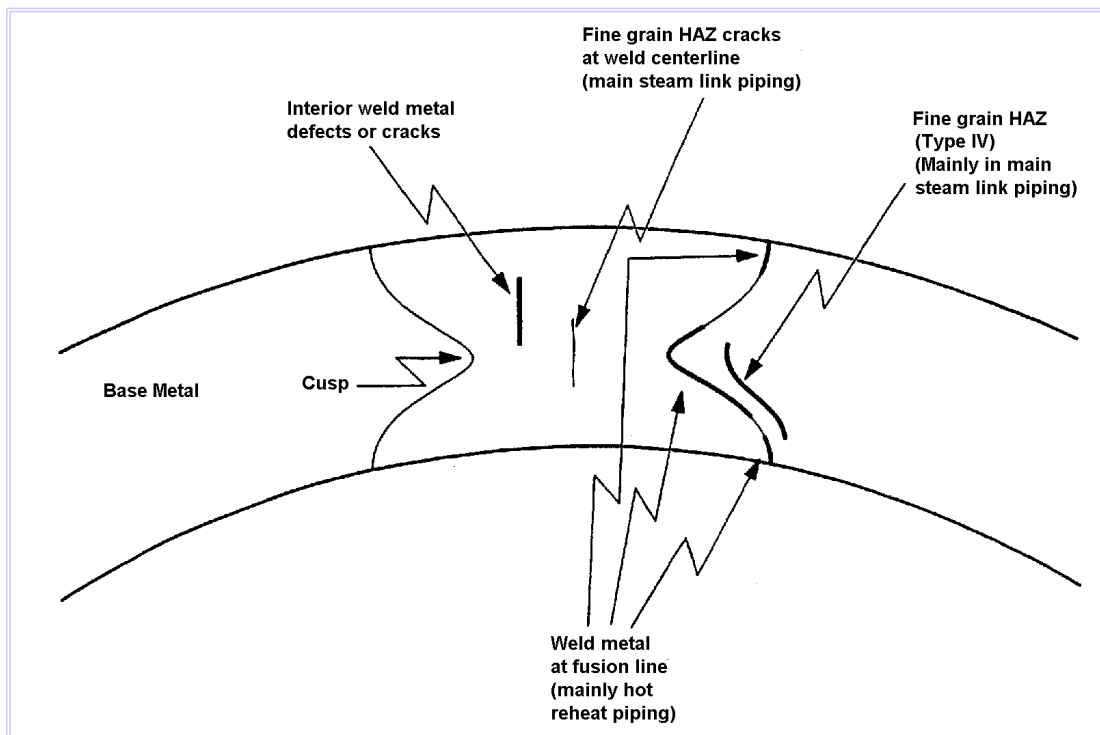
Figure 1. Typical high-temperature creep cracking defects occurring in seam-welded fossil piping systems constructed of P11 or P22 grade steels (1).

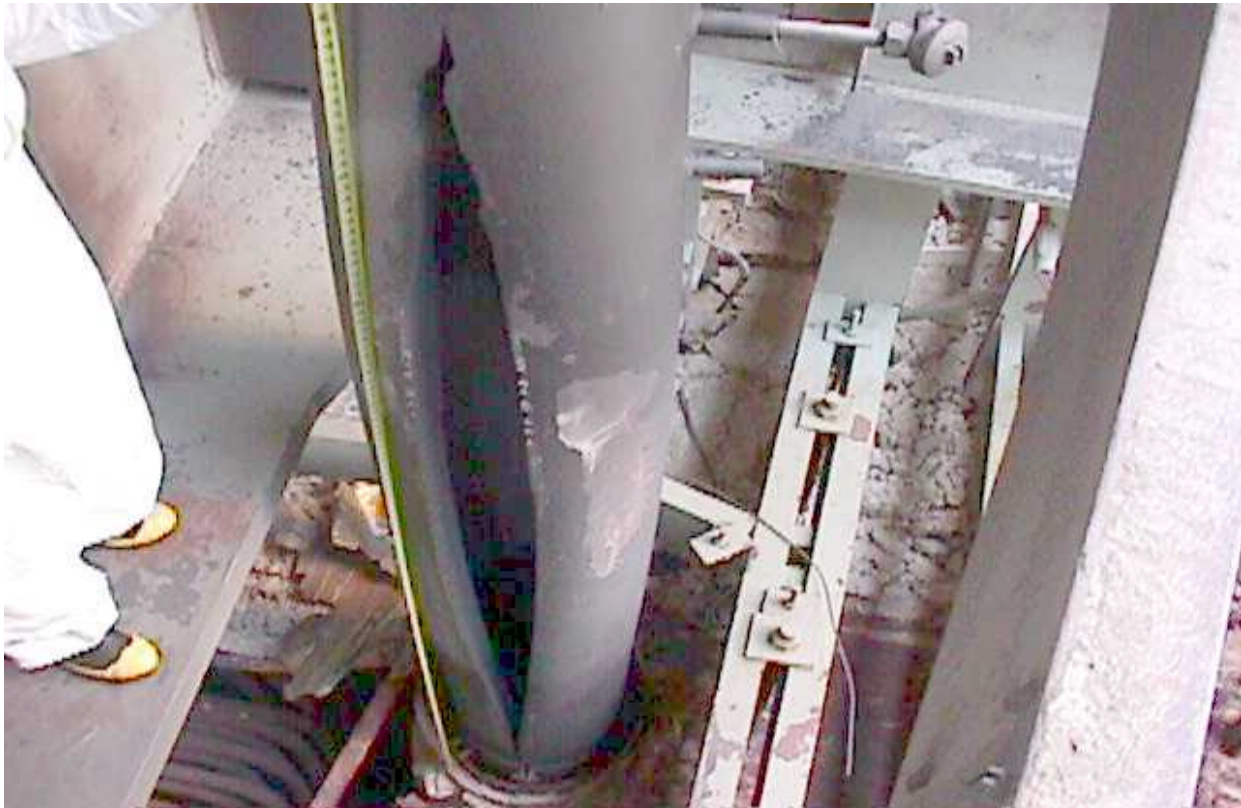
Beginning in 1992, however, there have been five known failures of seam-welded superheat (SH) link piping supplied with CE boilers. Two of these have been catastrophic: Virginia Power's Mt. Storm Unit 1 in June 1996, and Kansas City Power & Light's Hawthorne Unit 5 in August 1998 (Figure 2). No loss of life occurred in either of those two failures, but the cost of repairs and loss of power generation is of critical concern to utility companies in this age of growing competition. All failures of SH link piping have occurred on units with accumulated service time of 125,000 to 200,000 hrs. Compounding the problem of inspection is the inaccuracy of supplied documentation, which may not reflect the true alloy content and method of fabrication. The Hawthorne SH link piping was not known to be seam-welded. The general aging of fossil plants will continue to raise concerns about the safety of operating seamed high energy piping systems. Even seamless piping systems have had problems, including failures of circumferential welds, and the through-wall creep failure of a seamless SH bend that had been improperly fabricated. Current strategies for effectively managing the safety and life of seam-welded piping are based upon periodic inspection of the weld area for evidence of inservice damage.

Figure 2. Photograph of seam-welded pipe failure at Hawthorn Unit 5.

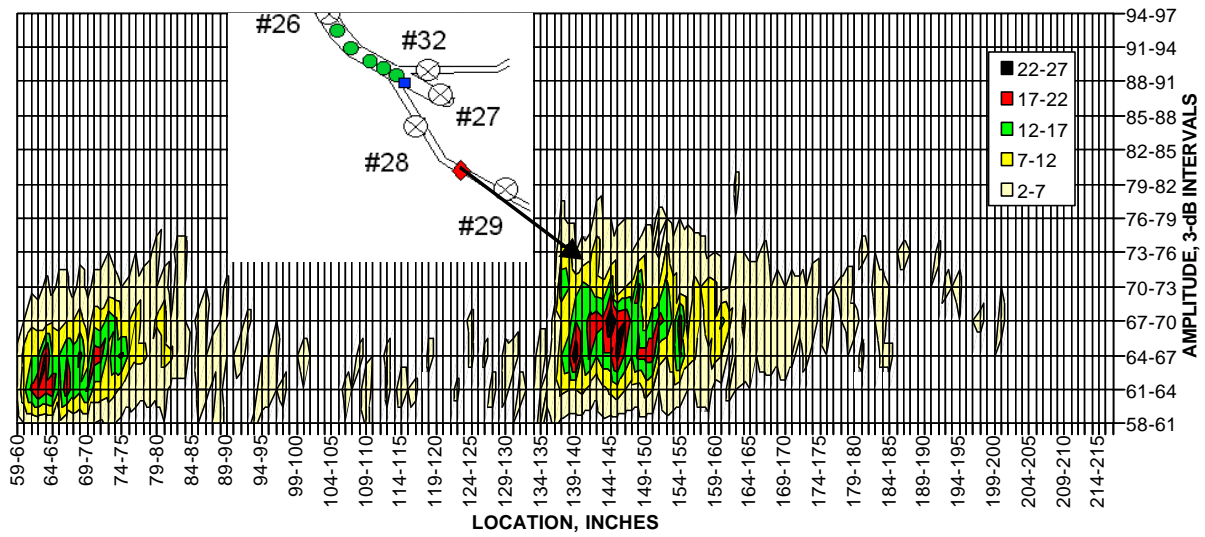
Figure 4. Example of event clusters of AE to identify significant sources for follow-up investigation.

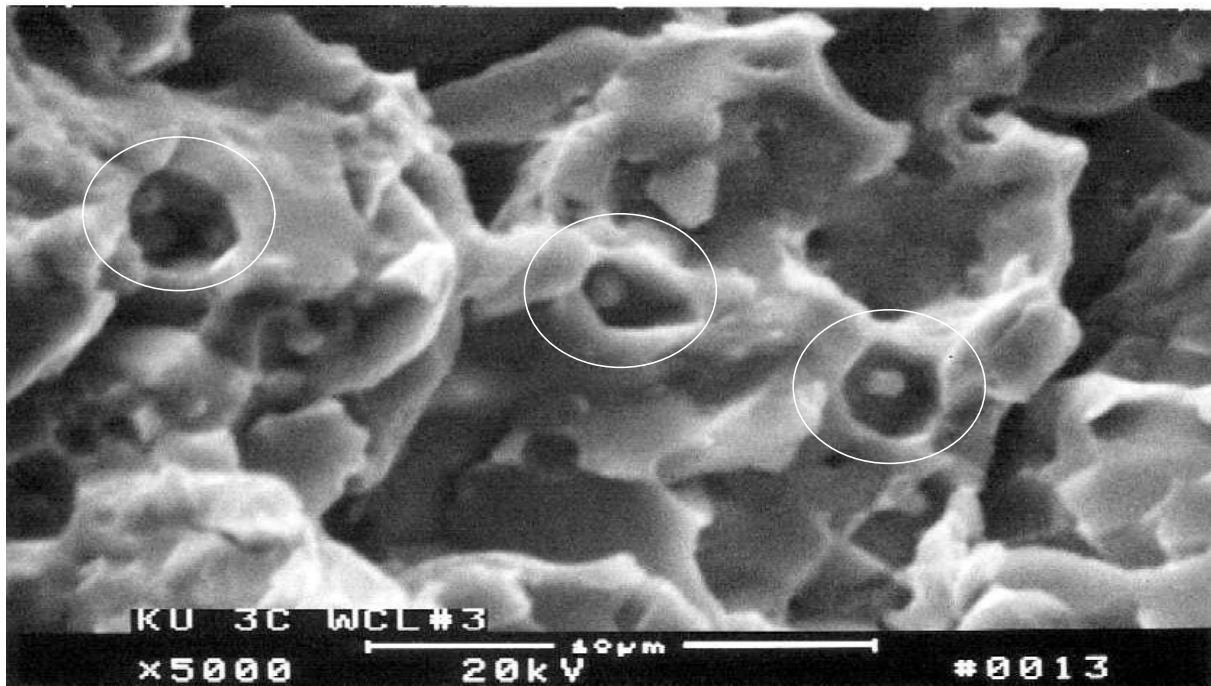
replacement. Similar AE activity was observed in the suspect area. One of the leads was removed and sent to the EPRI NDE Center in Charlotte, NC for further analysis. A phased-array automated UT inspection was performed on the seam weld, and significant indications were observed in a 24-inch long area matching the AE source location results. A 3" plug sample was taken for metallographic analysis. No cracking was evident with normal metallography, so the specimen was sent to Materials & Mechanical Engineering in Austin, TX (division of Hartford Steam Boiler) for further analysis. A reliable method of early creep detection is a method known as cryo-cracking. It is capable of identifying the condition when damage still exists as isolated cavitation around carbides and inclusions in the weld Heat Affected Zone (HAZ). The specimen is scored at the desired analysis location, submerged in liquid nitrogen to supercool the material, then impacted to break the material along the preferred plane. Careful examination under SEM magnifications of 5000x is required to observe the fine structural detail of the fracture surface. The cryo-cracking examination identified evidence of early-stage creep cavitation in the weld centerline (Figure 5). These sophisticated UT and metallographic methods confirmed that AE had identified a developing problem well ahead of the appearance of microcracking, which later would coalesce into a major crack. This added perhaps years to the early detection of the problem, and allowed the utility to remove a future hazard on a reasonably planned schedule.

Figure 5. SEM micrograph showing early stage creep damage in the centerline region of a seam-welded SH link pipe.
