SUMMARY OF FIELD EXPERIENCE FOR ACOUSTIC EMISSION MONITORING OF SEAM-WELDED HIGH ENERGY PIPING

J. M. Rodgers
Acoustic Emission Consulting
5000 San Juan Ave, Suite D
Fair Oaks, CA 95628

R. M. Tilley
EPRI
1300 W.T. Harris Blvd
Charlotte, NC 28262

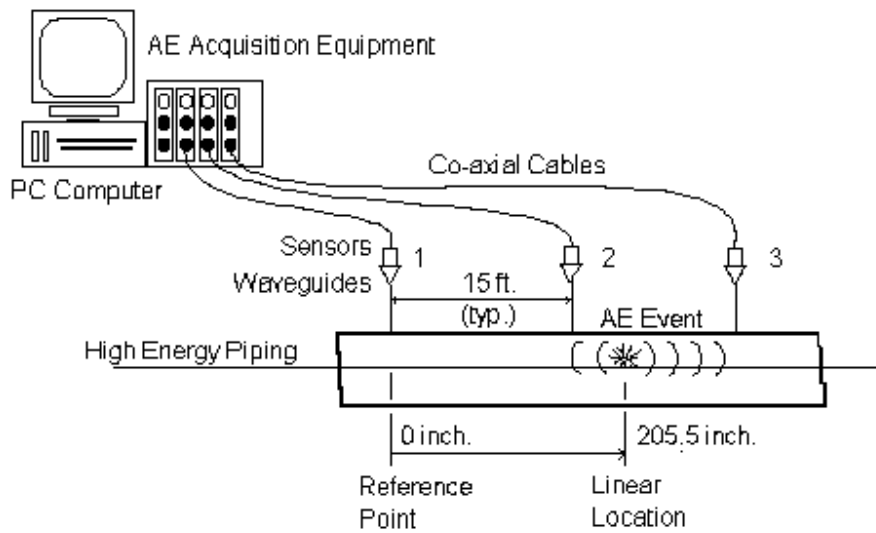
Beginning in 1992, however, there have been five known failures of seam-welded superheat (SH) link piping supplied with CE boilers. Two of these have been catastrophic: Virginia Power's Mt. Storm Unit 1 in June 1996, and Kansas City Power & Light's Hawthorne Unit 5 in August 1998 (Figure 2). No loss of life occurred in either of those two failures, but the cost of repairs and loss of power generation is of critical concern to utility companies in this age of growing competition. All failures of SH link piping have occurred on units with accumulated service time of 125,000 to 200,000 hrs. Compounding the problem of inspection is the inaccuracy of supplied documentation, which may not reflect the true alloy content and method of fabrication. The Hawthorne SH link piping was not known to be seam-welded. The general aging of fossil plants will continue to raise concerns about the safety of operating seamed high energy piping systems. Even seamless piping systems have had problems, including failures of circumferential welds, and the through-wall creep failure of a seamless SH bend that had been improperly fabricated. Current strategies for effectively managing the safety and life of seam-welded piping are based upon periodic inspection of the weld area for evidence of inservice damage.

Figure 2. Photograph of seam-welded pipe failure at Hawthorn Unit 5.
